# HIGHWAY STUDY REPORT

## FIBERGLASS ROVING FOR EROSION CONTROL

PONDEROSA ROAD AND HIGHWAY 50  
INTERCHANGE

FINAL REPORT

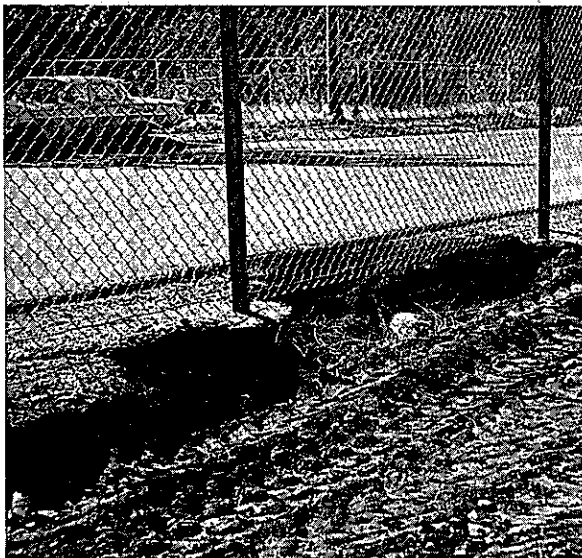
Erosion at this location has been a problem since construction of the road. Plate 2 illustrates the safety hazard caused by erosion undermining the frontage road at Location 1. Plates 3 and 4 illustrate the severe and hazardous erosion adjacent to an on-ramp at Location 2. Plate 5 indicates the deterioration of an A.C. lined ditch at Location 3. Plates 6 and 7 illustrate moderate

Plate 2  
Frontage Road Undermined  
by Erosion at Location 1

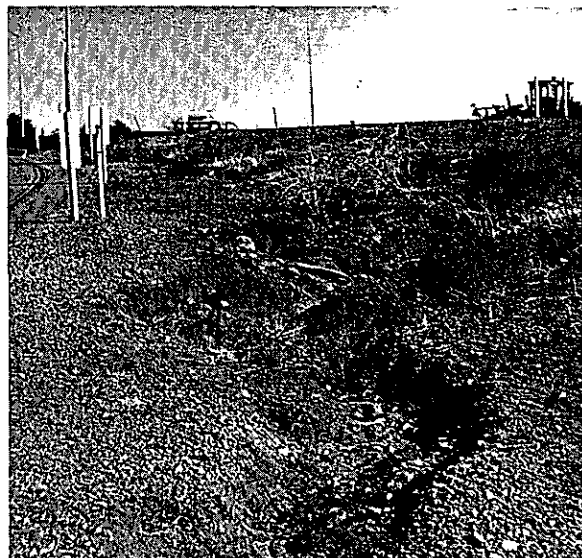
Plate 3  
Hazardous Condition  
at Location 2

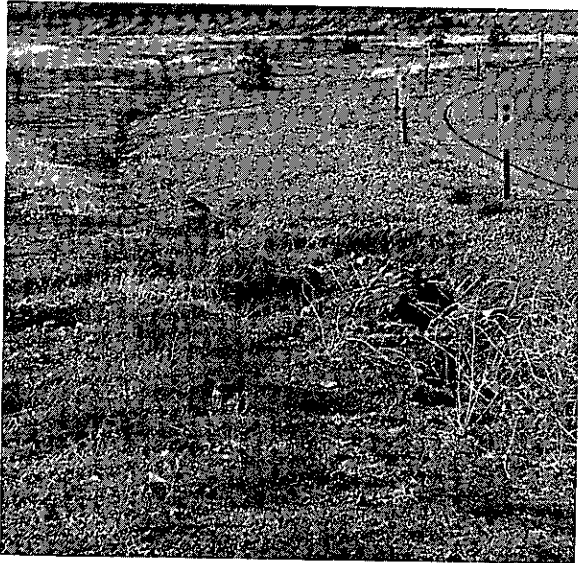
Plate 4  
Hazardous Condition  
At Location 2

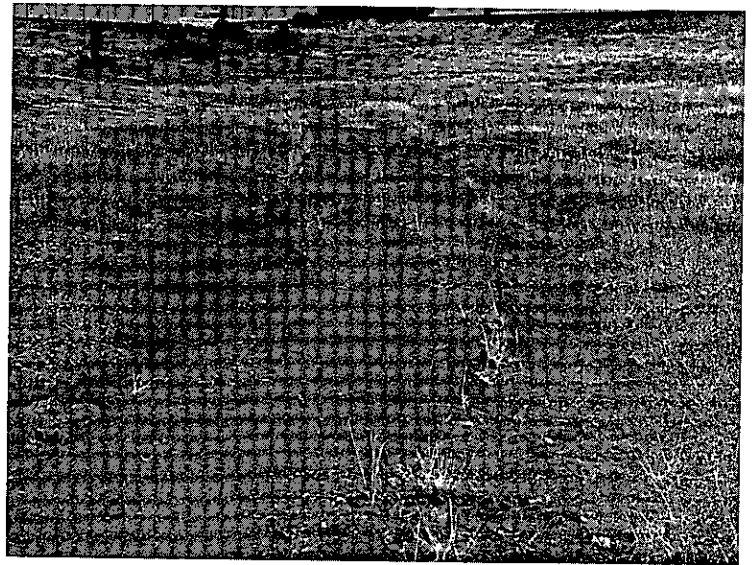
Plate 5  
Deterioration of an  
Asphalt Concrete Ditch  
At Location 3

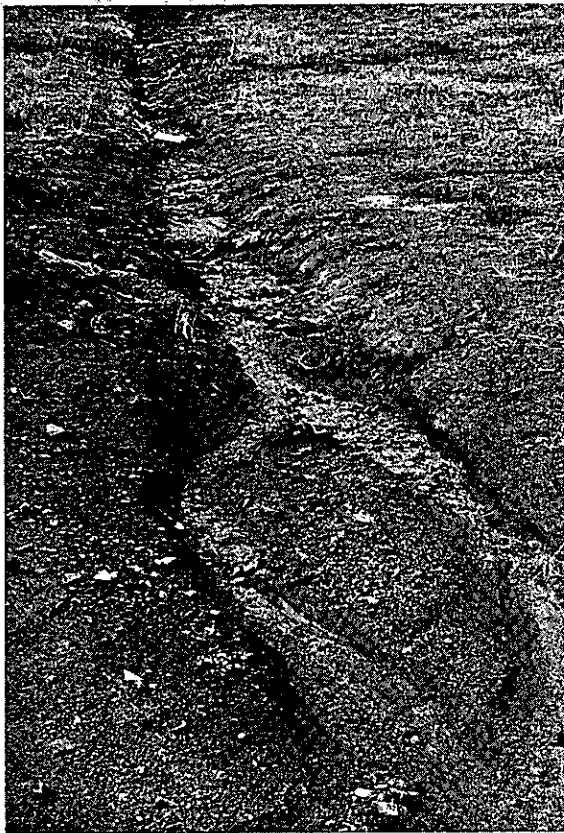
Plate 6  
Moderate Erosion  
At Location 4

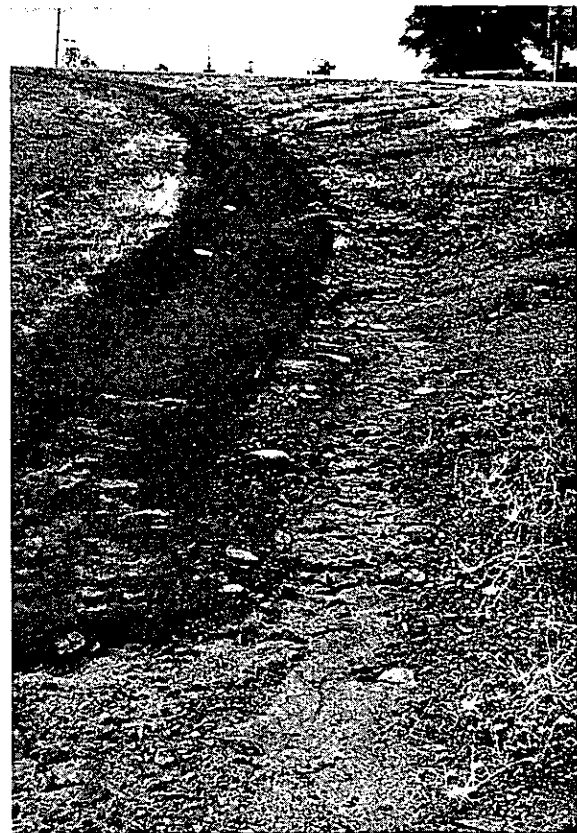
Plate 7  
Moderate Erosion  
At Location 4

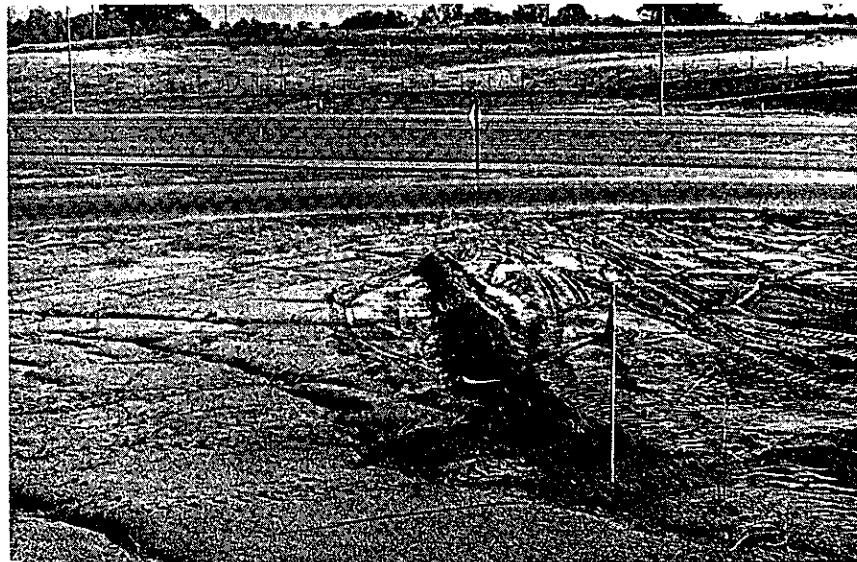
erosion at Location 4 while Plates 8 and 9 illustrate the severe erosion adjacent to the test plot at Location 5.

Plate 8  
Severe Erosion at Location 5

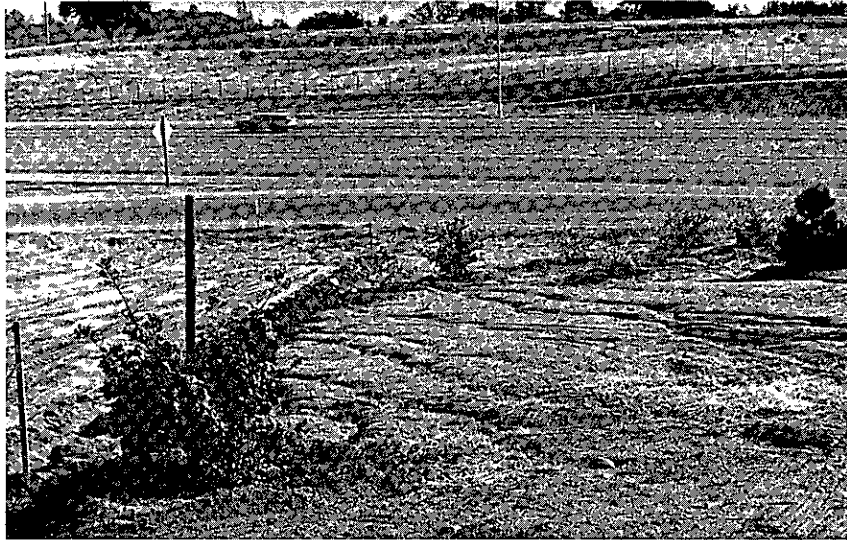
Plate 9  
Severe Erosion at Location 5

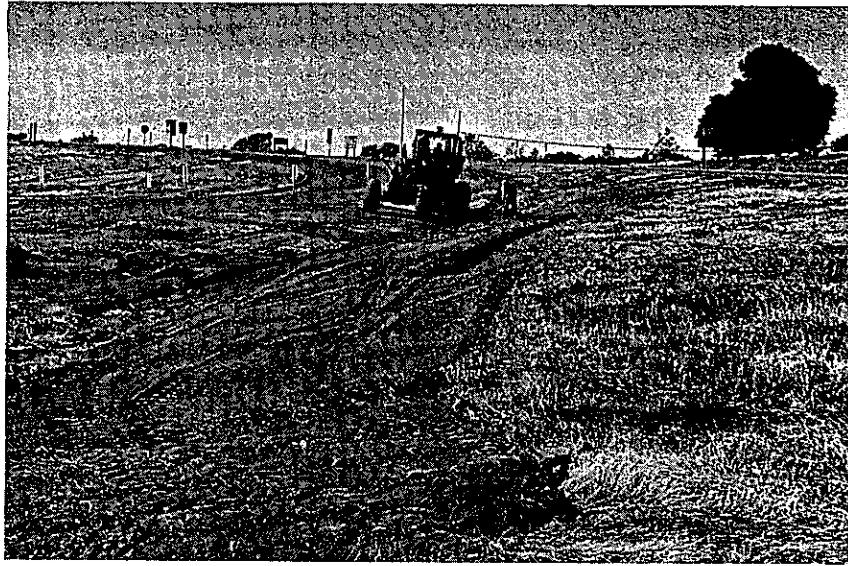
Plate 10  
Regrading Ditch at Location 4

Preparatory work at Locations 1, 2, 3 and 4 consisted of regrading the eroded ditches and reshaping the ditch into flat bottomed sections with flat slopes. (See typical sections on page 10) A rectangular section of slope at Location 5 was regraded to a smooth section. One-half foot deep lateral trenches were constructed at Locations 3, 4 and 5 to allow for burial of the fiberglass mat to eliminate undermining by lateral inflow. A one-foot deep trench was cut along the upgrade end at all five locations to allow for burial of the mat and to prevent undermining.

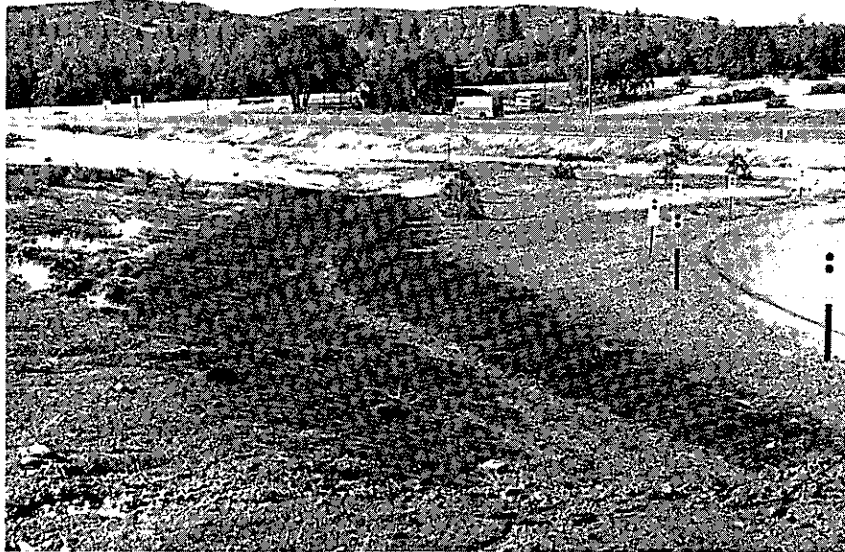
There was considerable lateral inflow at Location 2 as illustrated by Plates 17 and 18. However, the sides of the treated area were not undermined in spite of the omission of lateral trenches. This indicates that the use of lateral trenches to bury the sides of the mat is not necessary for conditions experienced during the test period.

Plate 17  
Lateral Inflow at Location 2

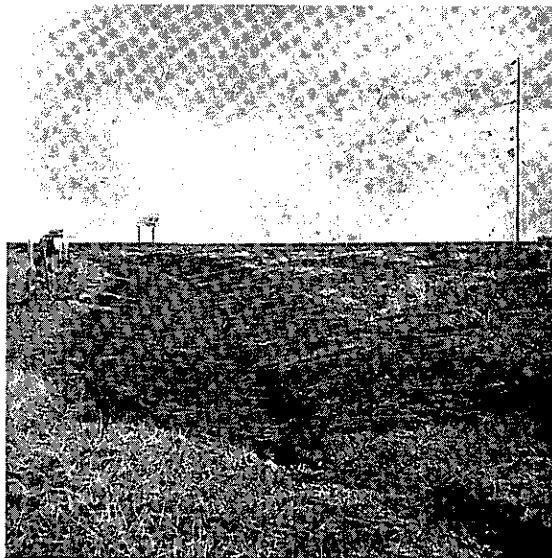
Plate 18  
Lateral Inflow at Location 2

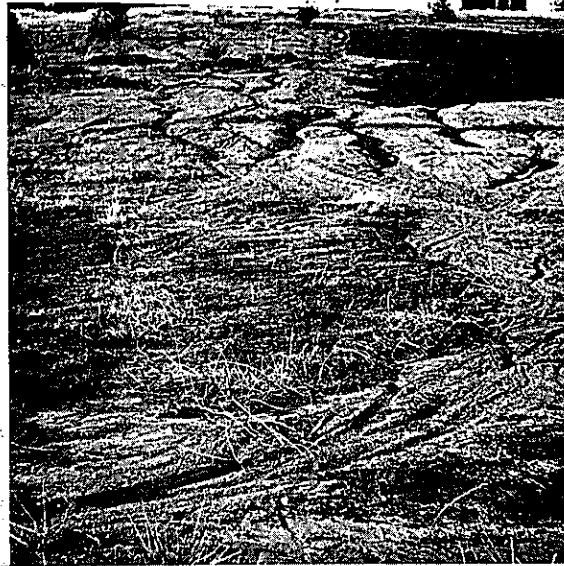
Plates 19 and 20 illustrate the progressive severity of the erosion along the sides of the mat at Location 5. This concentrated

Plate 19  
Progressive Erosion at Untreated Adjacent Areas

erosion was caused by the lateral trenches which were constructed to bury the sides of the mat and indicates that installing the trenches may have created an adverse effect.

In the preparation of sites prior to the application of fiberglass roving, it is recommended that lateral trenches for the burial of the sides of the mat should not be constructed. However, the upper and lower end of the mat should be buried in a one-foot deep trench to prevent undermining at these locations. It is recommended that asphalt be applied at a rate of 0.25 to 0.35 gals./square yard.

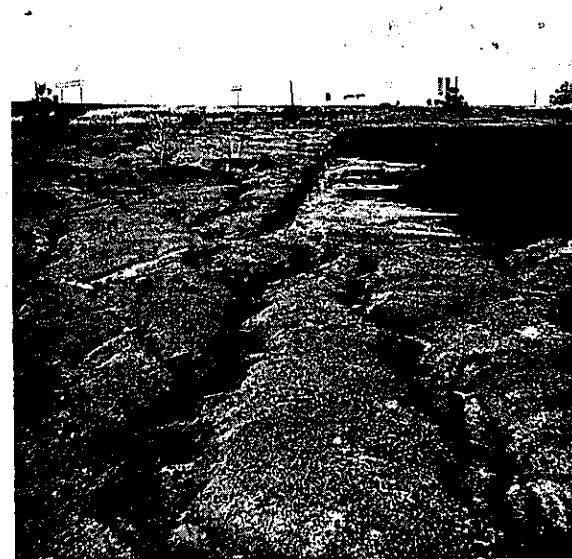
Plate 20  
Progressive Erosion at Untreated Adjacent Areas

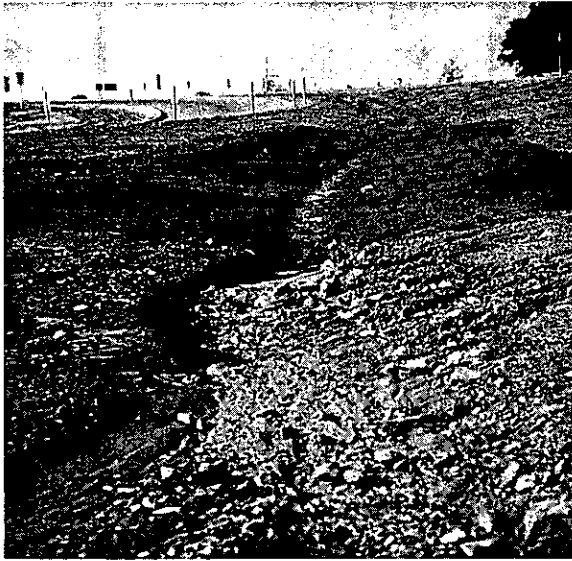
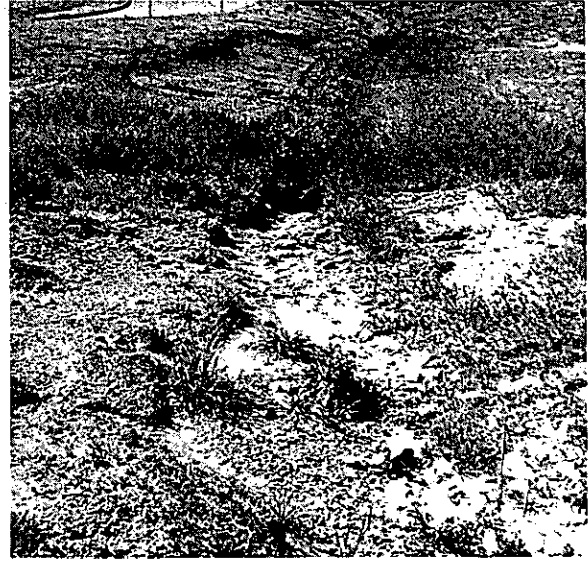
There were a few small spots at Locations 3, 4 and 5 where over-application of asphalt sealed the mat and appeared to hinder vegetal growth. However, most of the grasses managed to emerge through the asphalt. The rather poor grass growth at the south half of Location 4 (see Plates 21 and 22) was possibly due to a lack of or low application of fertilizer.

Lower Rate of Grass  
Growth at Location 4
